ΤΟ ΚΑΣΤΡΟ ΑΚΡΟΚΟΡΙΝΘΟΥ και η ανάδειξή του(2006-2009)

THE CASTLE OF ACROCORINTH
and its enhancement project (2006-2009)

ΑΝΑΠΛΑΣΗ – ΑΝΑΔΕΙΞΗ ΑΡΧΑΙΟΛΟΓΙΚΟΥ ΧΩΡΟΥ ΚΑΣΤΡΟΥ ΑΚΡΟΚΟΡΙΝΘΟΥ Ν. ΚΟΡΙΝΘΙΑΣ

ENHANCEMENT OF THE ARCHAEOLOGICAL SITE OF ACROCORINTH CASTLE, CORINTHIA

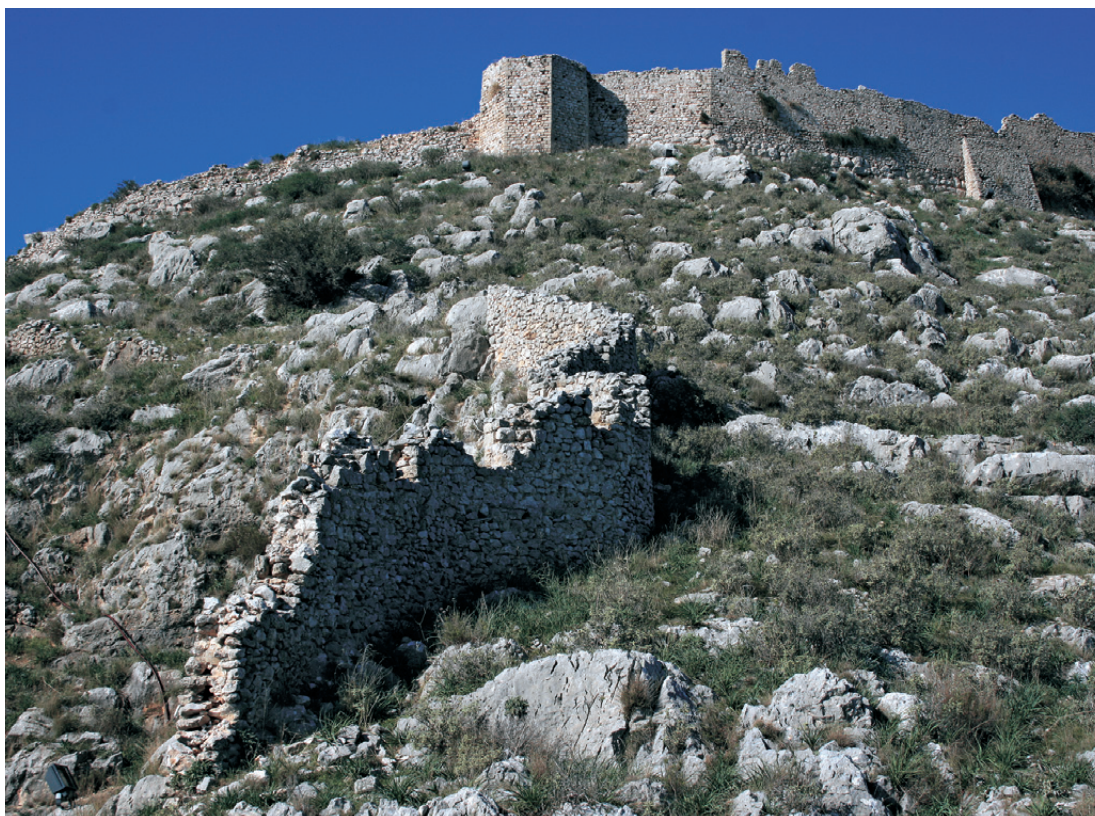
Εικόνα 2B:
τμήμα του
ανατολικού
περιβόλου μετά
την κατάρρευση
(2008)

encountered. In the meantime, deterioration of the site continues to accrue, sadly leading to irreversible losses. A simple comparison of photographs from the period before WWII to this day suffices to illustrate the extensive collapse the monument has suffered due to deterioration solely from environmental factors (fig. 2A-B). This rapid and progressive disintegration has, within the span of less than a century, resulted in the collapse of gates, the reduction of long stretches of walls to rubble piles, while more delicate structural elements, such as crenellations, have completely vanished over hundreds of meters of fortifications. The state of preservation of the settlement ruins is even worse, as the inferior construction and the continuous use of the area until the early 19th c. has caused the destruction of the majority of medieval buildings, the presence of which is detectable today only through excavations.

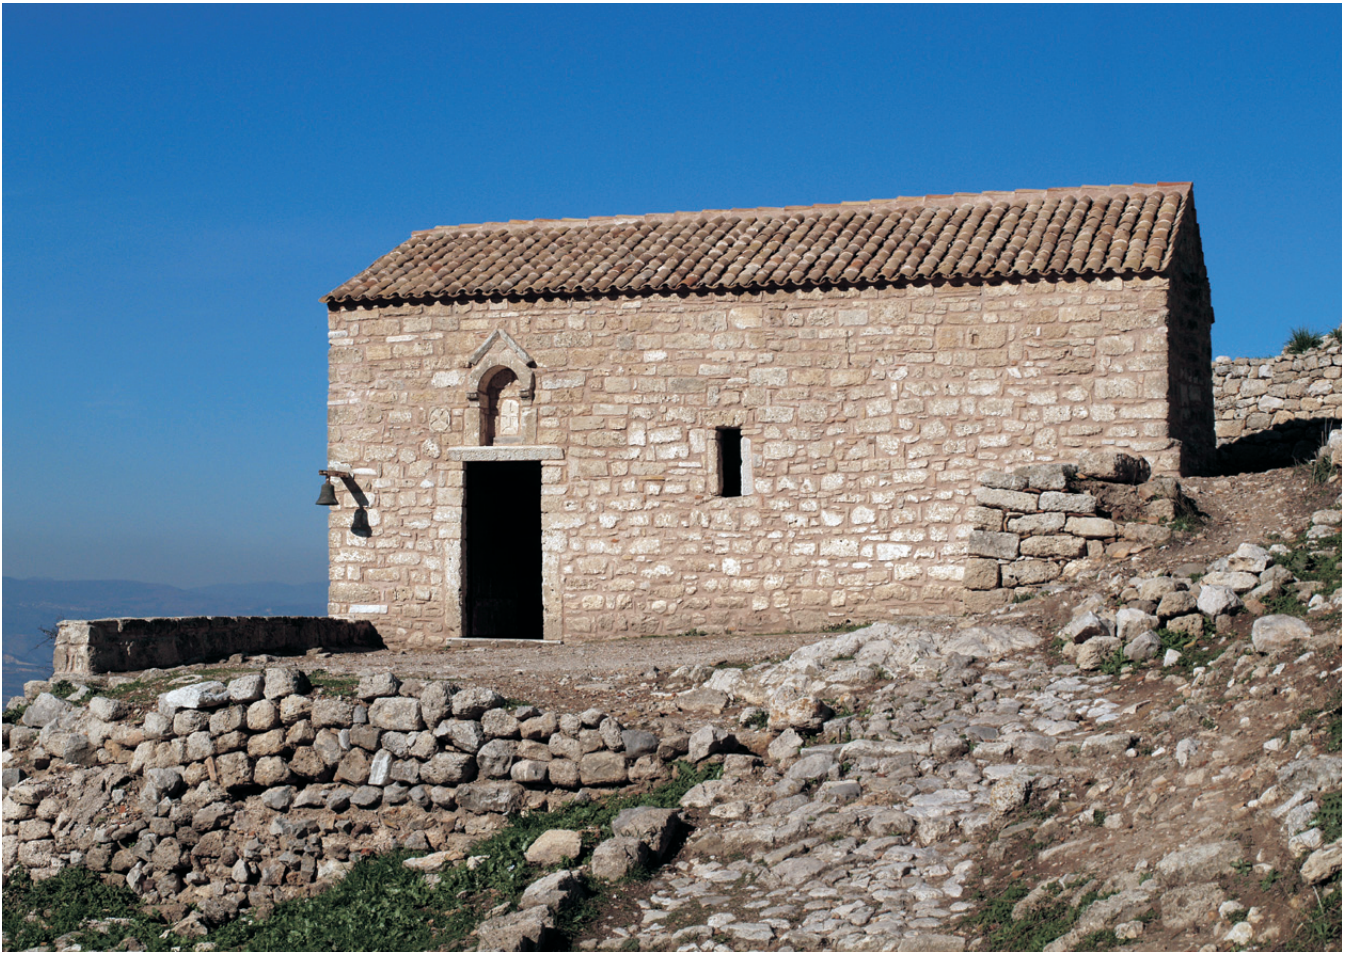
Εικόνα 7:
ναός Αγίου
Δημητρίου [17]

In the church of St. Demetrios [17] (fig. 7), plaster was removed and loose mortar joints were cleaned in depth on the exte-

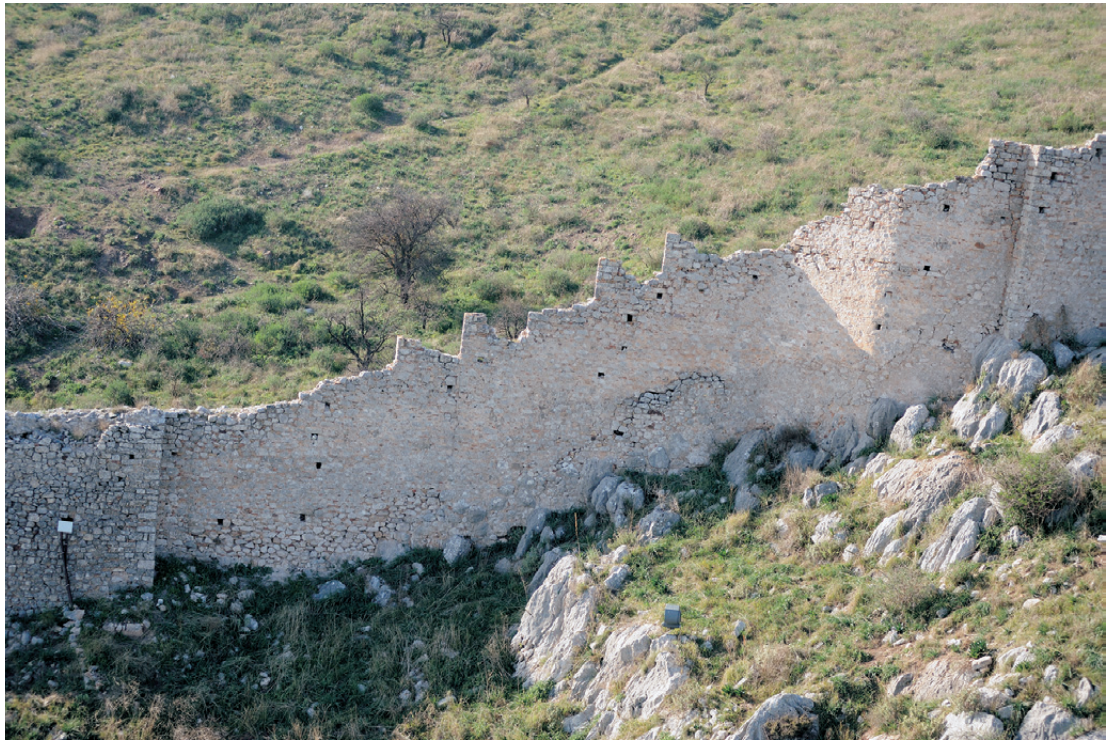
Figure 39:
section of the
eastern circuit
wall with Middle
Byzantine rough
masonry and
parapets

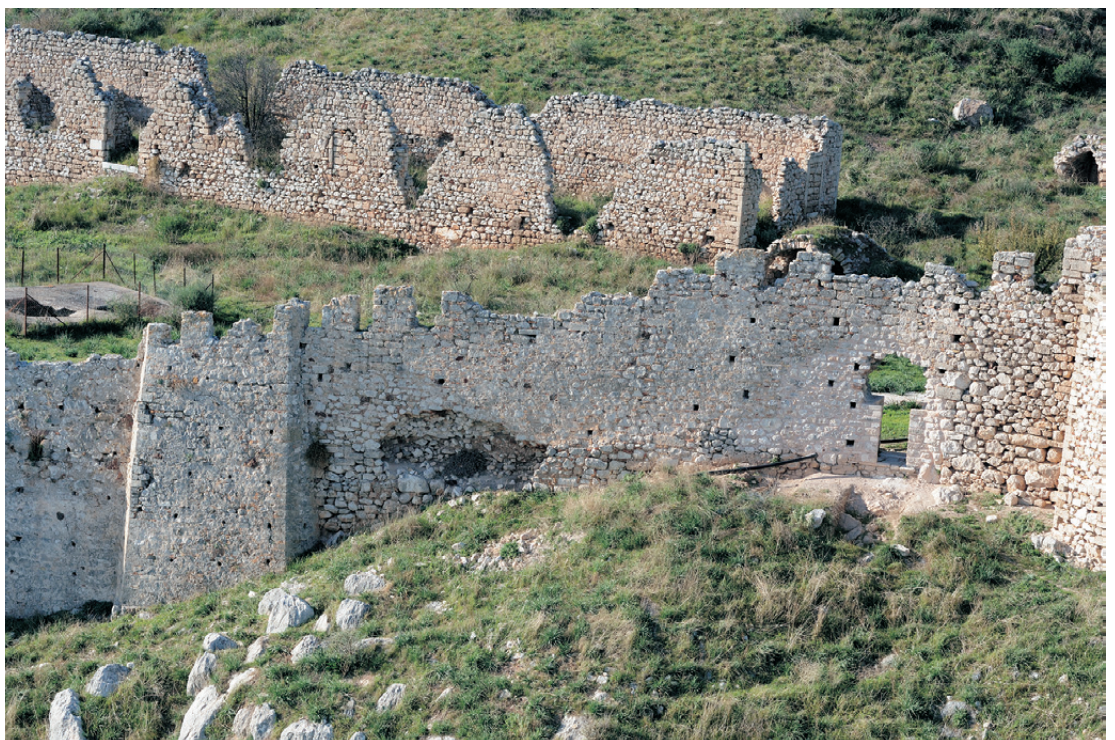
Εικόνα 40:
τμήμα νότιου
περιμετρικού
τείχους [IV14-
IV15] με την
αμελέστερη
μεσοβυζαντινή
τοιχοποιία, την
πυλίδα G7 και
με επάλξεις δύο
φάσεων

Figure 40:
section of the
south circuit
wall [IV14-
IV15] with rough
masonry, postern
G7 and parapets
of two phases
superimposed

Έτσι, επιλέχθηκε να διαμορφωθεί το άνοιγμα μόνο μέχρι το σημείο που υπήρχαν ασφαλή στοιχεία και να μην αποκατασταθεί το υπέρθυρο (εικ. 40, 85).

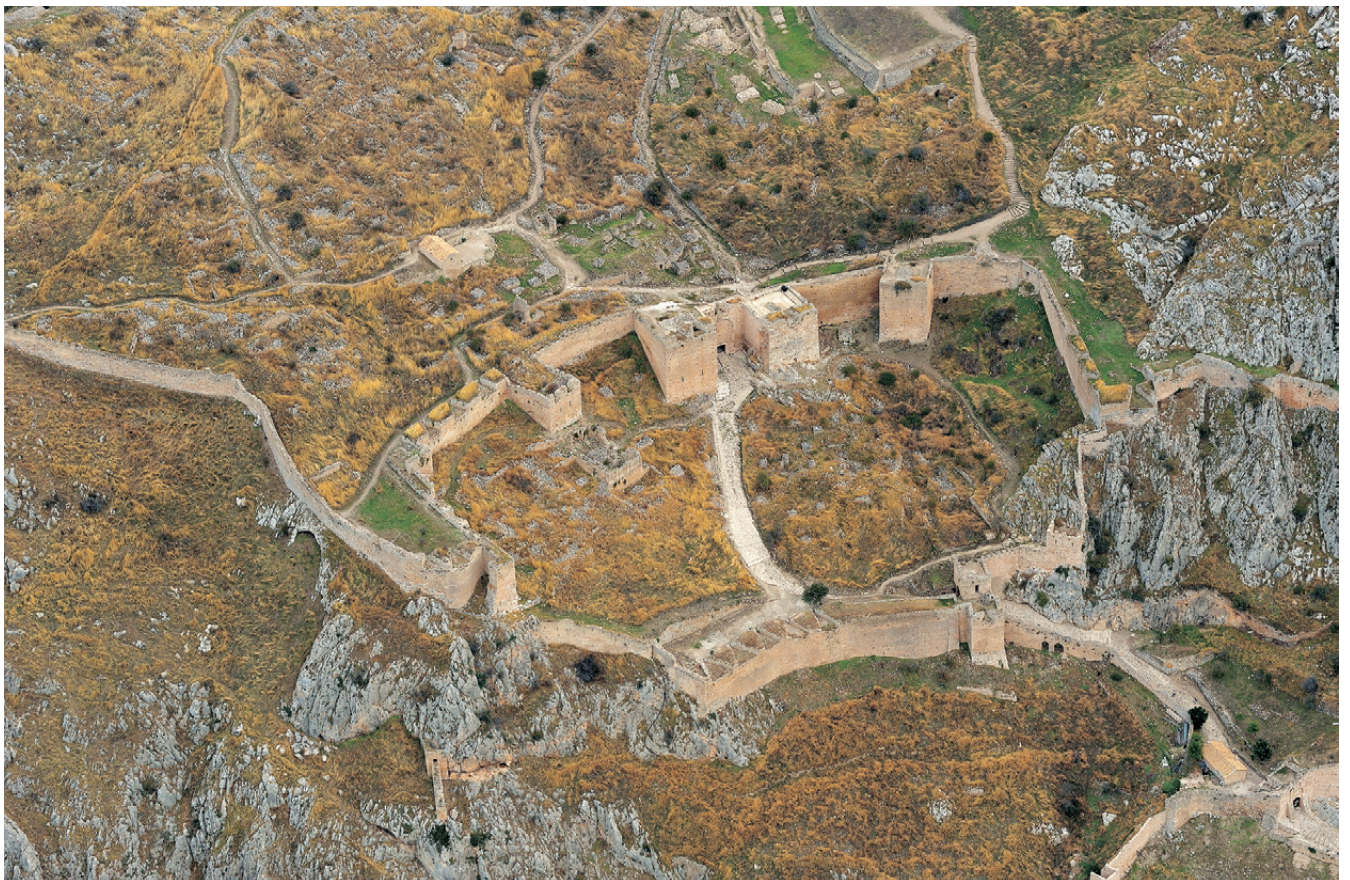
Figure 41:
west
fortifications.
Lines of defense
II and III

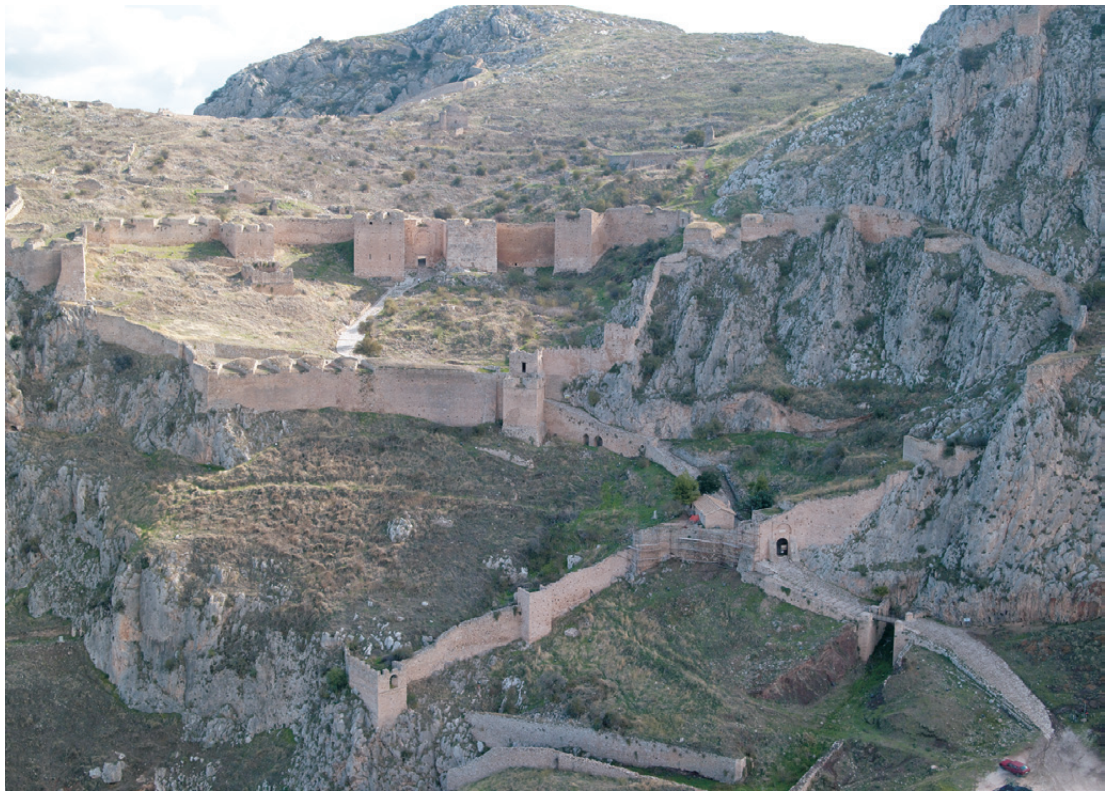
Εικόνα 42:
δυτικές οχυρώσεις:
η τάφος και οι
γραμμές I, II και III

Figure 42:
west
fortifications: the
moat trench and
the three lines of
defense I,
II and III

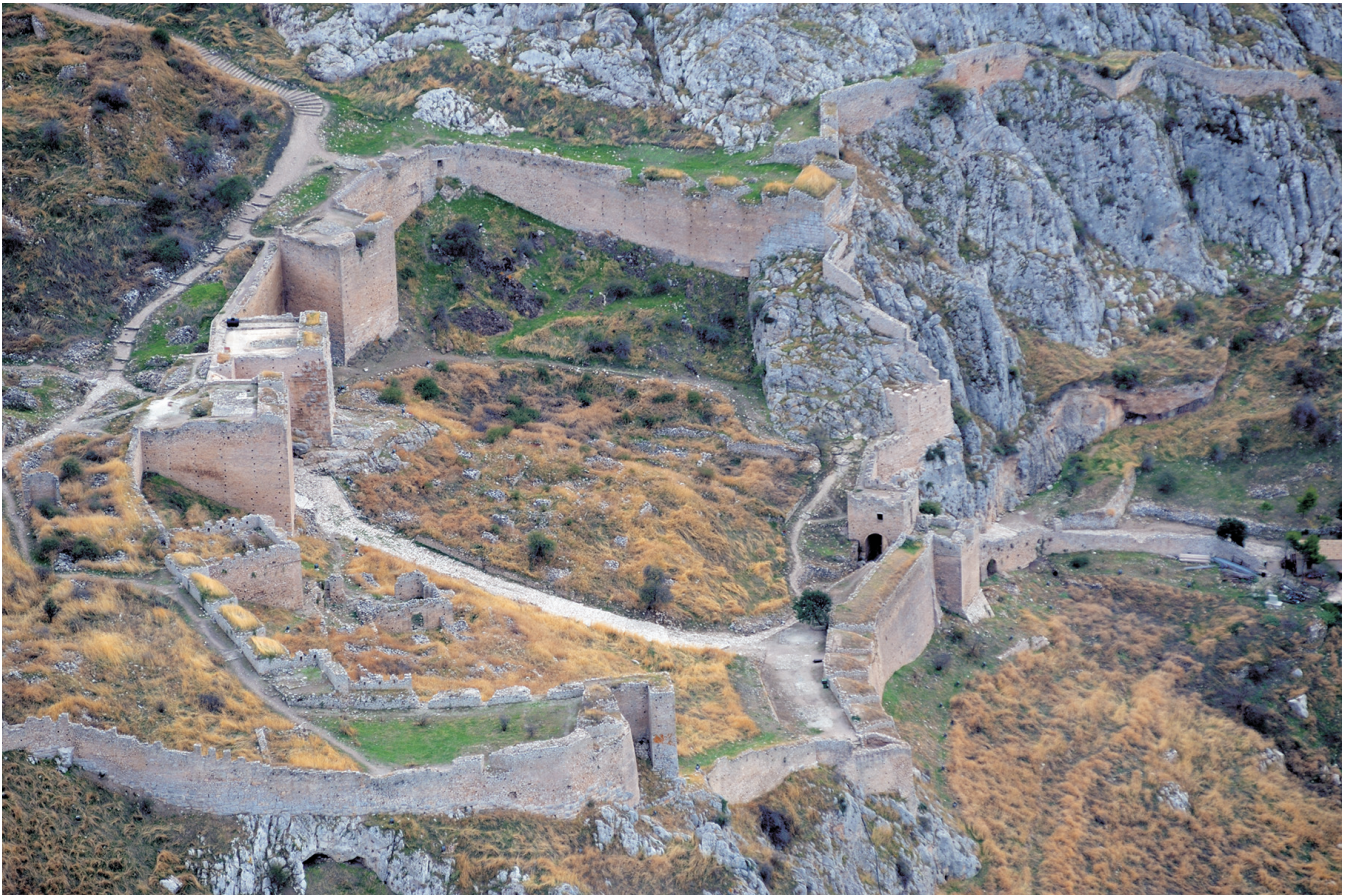
Figure 46:
gate G2. First
floor plan

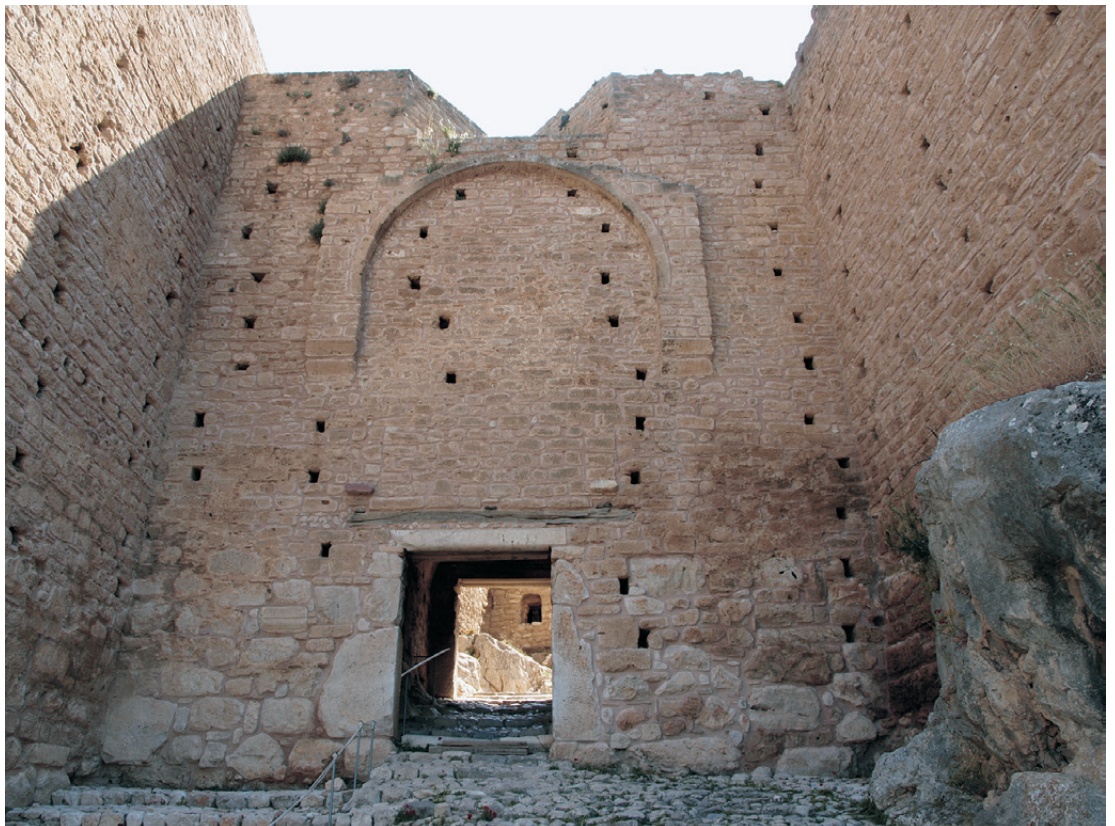
Figure 50
gate G3. Façade

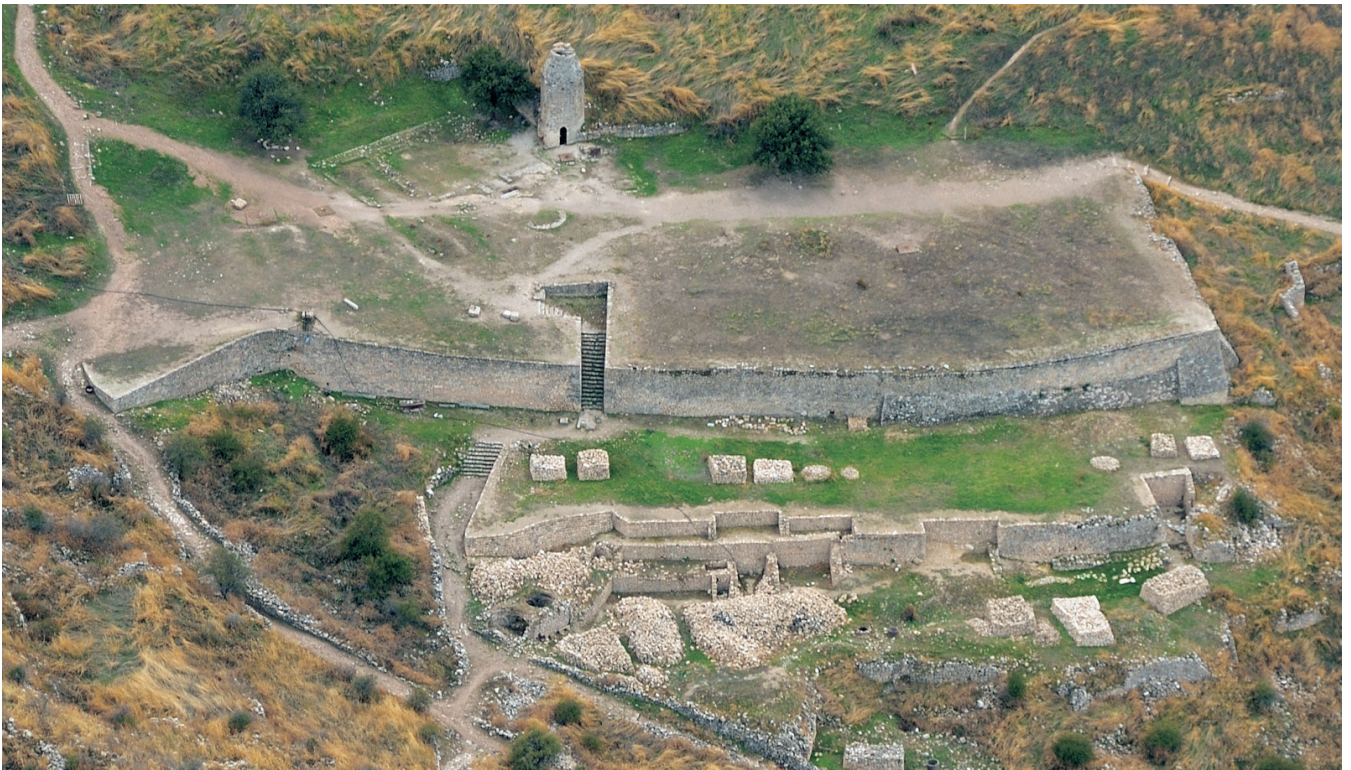
Figure 73:
the area of the retaining walls with the byzantine cistern 4 and the mosque 7 after the consolidation works

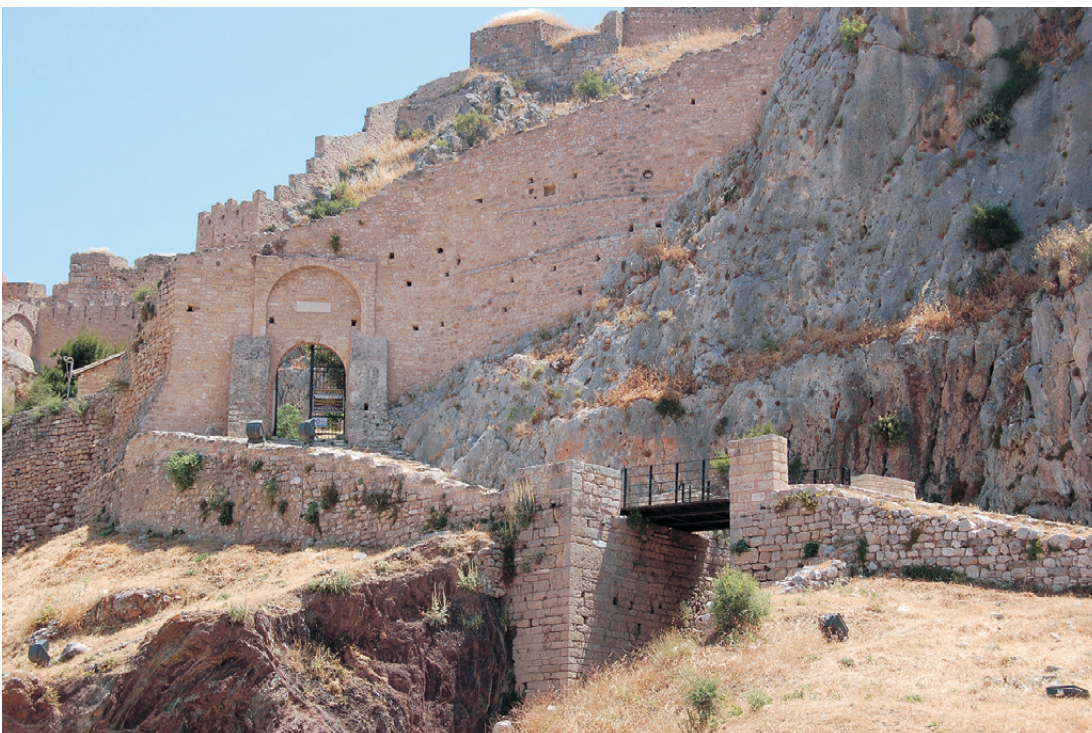
Εικόνα 79:
γέφυρα τάφρου
Μ και η πύλη G1
της εξωτερικής
γραμμής
οχύρωσης Ι

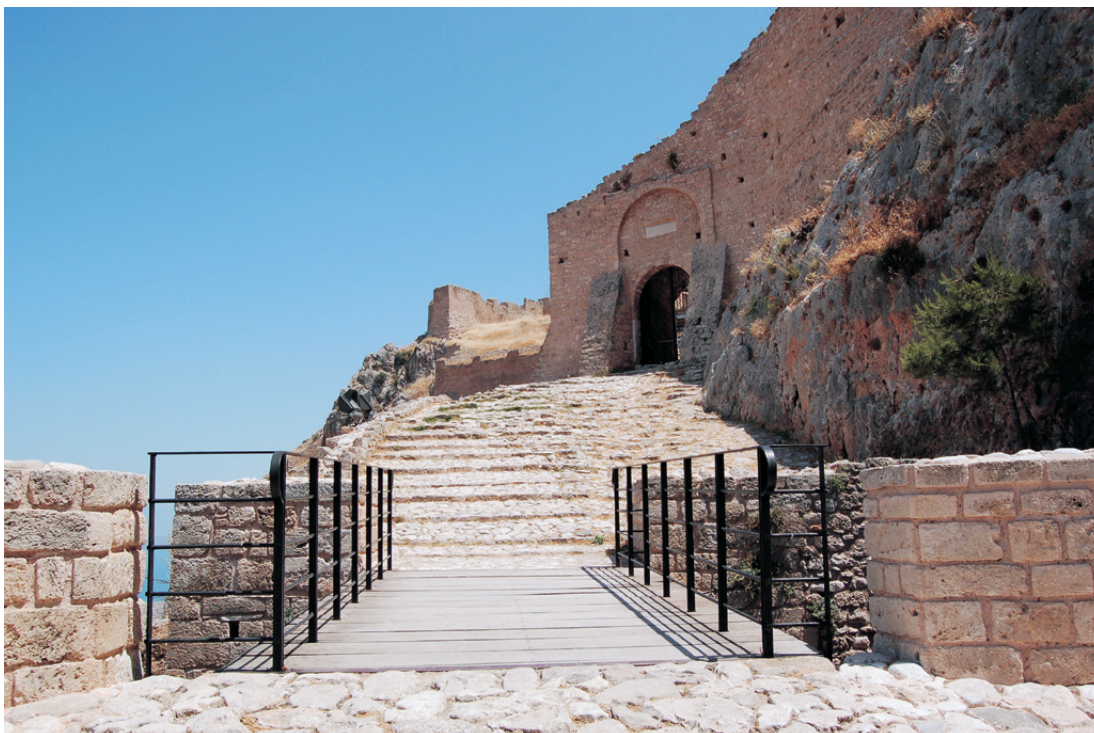
Εικόνα 82:
αποκατάσταση
γέφυρας τάφρου Μ
